DEMANDING DRIVE KITS

Dayco® demanding drive kits provide all the required components to ensure a quiet, problem-free belt drive system. These kits have been designed to address the most demanding drives in the market. Dayco® demanding drive kits include the Dayco® Quiet Design serpentine belt, using advanced, state-of-the-art manufacturing processes to ensure it is one of the quietest belts for today's vehicles.

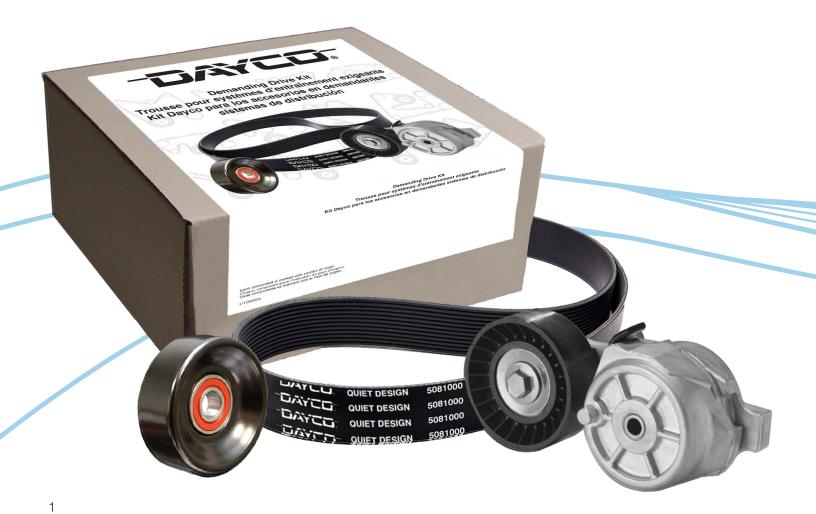
These application-specific kits can include the Dayco® Quiet Design serpentine belt, a Dayco® No Slack® automatic belt tensioner, a Dayco® No Slack® idler/tensioner pulley, and a Dayco® overrunning alternator pulley, when applicable.

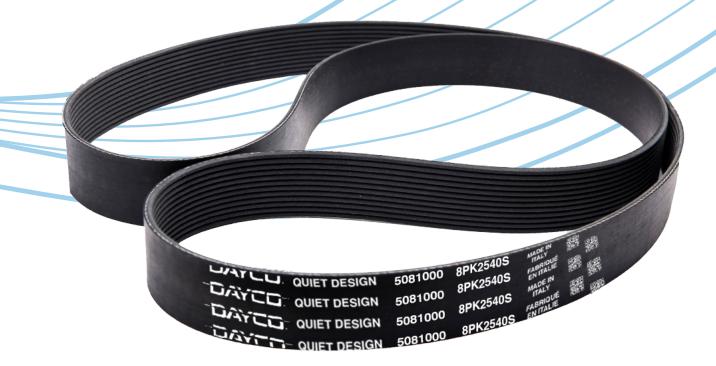
DAYCO® QUIET DESIGN SERPENTINE BELT

- Exclusive to Dayco's Demanding Drive Kit
- Quietest belt ever tested by Dayco®
- Engineered for the most demanding drives in the market
- Utilizes specific compound for noise mitigation
